**Flood Control Project Maintenance
Levee Inspections**

Maintenance Issue Types Only, Levee Inspection Report By Mile - Spring 2019

Sutter Maintenance Yard Maintenance Area 0013

Waterway	Bank	Unit Miles	Inspection Start/End	Inspector
Unit No. 01 Cherokee Canal	Right	18.19	05/15/2019 05/15/2019	Makar Sokol

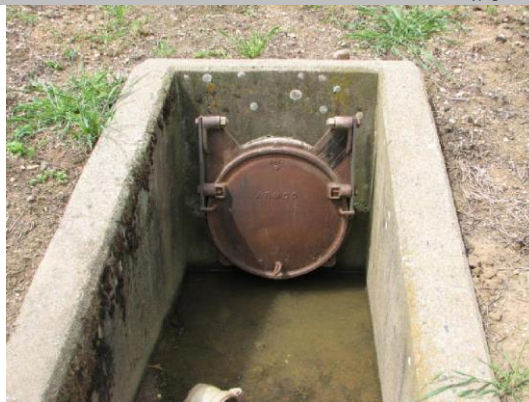
Photo 2 of 3 : UCIP_SP_2019_52180_66688.jpg

Comment Code					
Inspector Comment					
FS_ID:52180 DS_ID:16343 EP_NO: N/A Repair Type: No Action Needed Crossing Status: Found UCIP Comments: 6/14/2017 Crossing appears to be in good condition. Pipe has been selected to be internally cleaned and inspected as part of the DMP project. (DWR Sutter Yard- AFreitag)11/16/2016 Crossing appears to be in good condition. (DWR Sutter Yard- AFreitag)4/28/2016 Crossing appears to be in good condition.7/14/2015 Crossing appears in good condition. No noticeable issues to report.5/21/2014 Same as last inspection.12/2/2013 Same as last inspection.7/10/2013 Same as last inspection.4/17/2012 Drain is still in use. 4 inch pipe in channel near WS headwall (see photo). The pipe does not appear to impact the crossing. FIELD_STRUCT_DESC: 24-inch corrugated metal drainage pipe through the levee, 8.6 feet below the crown. Concrete "U" headwalls on both the waterside (WS) and landside (LS). Flap gate on the WS end. [Additional Reference(s): DWR Levee Log, 1993. USACE Sacramento O&M Manual 519, June 1962 (HLM 1.15)] FS Date: 6/16/2017 10:11:43 AM

View of WS headwall and flap gate.

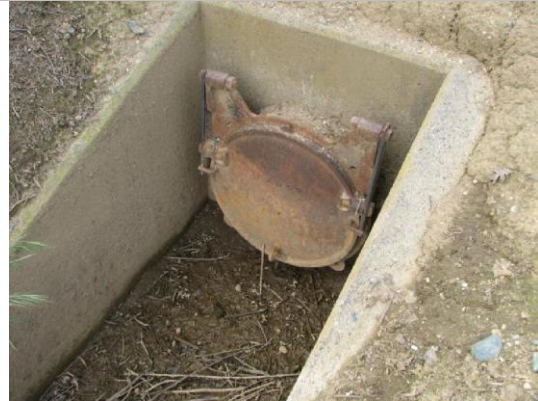
Photo 2 of 3 : UCIP_SP_2019_52185_66714.jpg

Comment Code					
Inspector Comment					
FS_ID:52185 DS_ID:16347 EP_NO: N/A Repair Type: No Action Needed Crossing Status: Found UCIP Comments: 6/14/2017 Crossing appears to be in good condition. (DWR Sutter Yard- AFreitag)11/16/2016 Crossing appears to be in good condition. (DWR Sutter Yard- AFreitag)4/28/2016 Crossing appears to be in good condition.7/14/2015 Crossing appears in good condition. No noticeable issues to report.5/21/2014 Same as last inspection.12/2/2013 Same as last inspection.7/15/2013 Same as last inspection.4/17/2012 Vegetation/sedimentation from WS has been removed. This crossing was listed in the USACE Periodic Inspection report as Corp's inspect ID#USACE_CESPK_M13D_2011_p_0130 for WS flap gate closed and blocked by sediment. FIELD_STRUCT_DESC: 24-inch corrugated metal drainage pipe through the levee, 9.4 feet below the crown. Concrete "U" headwall on both waterside (WS) and landside (LS) ends. Flap gate on the WS end. [Additional Reference(s): DWR Levee Log, 1993. USACE Sacramento O&M Manual 519, June 1962 (HLM 2.74)] FS Date: 6/16/2017 12:27:02 PM

Flap gate at WS.

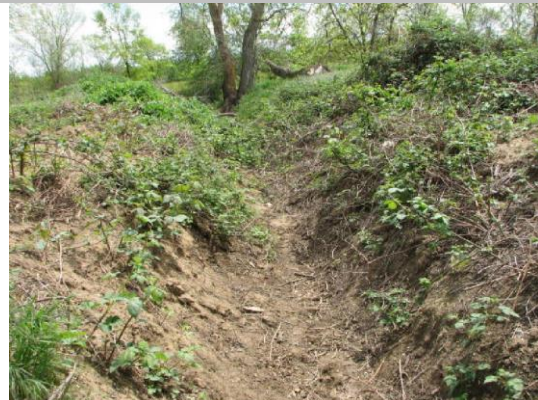
Photo 3 of 3 : UCIP_SP_2019_52185_66711.jpg

View of channel.

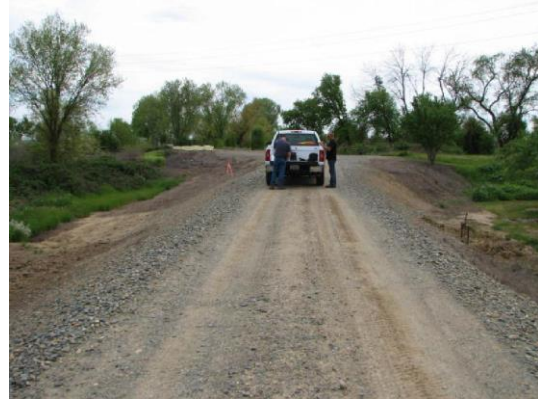
Photo 1 of 3 : UCIP_SP_2019_52188_66725.jpg

FS_ID:52188
DS_ID:16349
EP_NO: N/A
Repair Type: Non-Urgent
Crossing Status: Found
UCIP Comments: 6/14/2017 Both pipe ends and gates are mostly buried- need to be dug out. Pipe has been selected to be internally cleaned and inspected as part of the DMP project. (DWR Sutter Yard- A/Freitag)11/16/2016 Both gates closed but partially buried and unable to open. (DWR Sutter Yard- A/Freitag)4/28/2016 Sediment build up on both gates blocking them from operating properly.7/14/2015 Crossing appears in good condition. No noticeable issues to report.5/21/2014 Same as last inspection.12/2/2013 Same as last inspection.7/15/2013 Stem on LS screw gate has been replaced and is now full functional.4/17/2012 LS slide gate stem is bent and prevents gate from fully closing. Both WS and LS have been cleared of debris and sediment. This crossing was listed in the USACE Periodic Inspection report as Corp's inspect ID#USACE_CESPK_M13D_2011_p_0162 for inoperable gates on WS & LS due to sediment and grass blocking inlet and outlet.

Overview of levee crown looking DS at crossing.

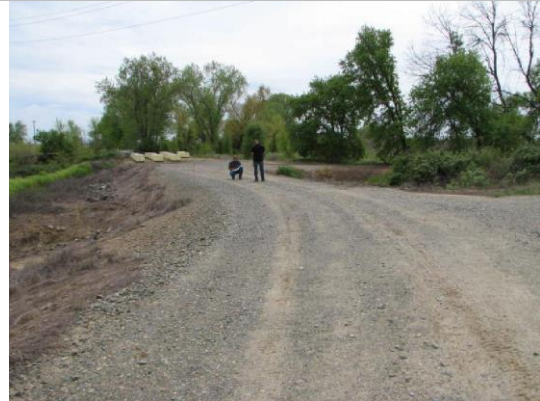
Photo 1 of 3 : UCIP_SP_2019_52189_66731.jpg

Overview of levee crown at crossing.

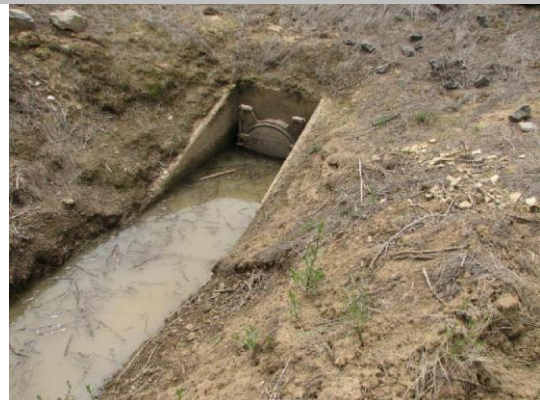
Photo 2 of 3 : UCIP_SP_2019_52189_66730.jpg

Comment Code					
Inspector Comment					
FS_ID:52189					
DS_ID:16350					
EP_NO: N/A					
Repair Type: No Action Needed					
Crossing Status: Found					
UCIP Comments: 6/14/2017 WS flapgate is buried by sediment- needs to be dug out. Pipe has been selected to be internally cleaned and inspected as part of the DMP project. (DWR Sutter Yard- A/Freitag)11/16/2016 Crossing appears to be in good condition. (DWR Sutter Yard- A/Freitag)4/28/2016 Crossing appears to be in good condition.7/14/2015 Crossing appears in good condition. No noticeable issues to report.5/21/2014 Same as last inspection.12/2/2013 Same as last inspection.7/15/2013 Same as last inspection.4/17/2012 WS headwall has been cleared of debris and sedimentation.					
FIELD_STRUCT_DESC: 24-inch corrugated metal drainage pipe through the levee, 8.4 feet below the crown. Concrete "U" headwalls on both the waterside (WS) and landside (LS) ends. Flap gate on the WS end. [Additional Reference(s): DWR Levee Log, 1993. USACE Sacramento O&M Manual 519, June 1962 (HLM 3.31)]

View of WS flap gate.

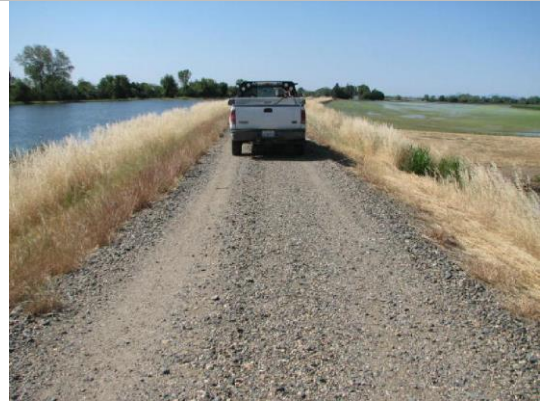
Photo 1 of 3 : UCIP_SP_2019_52190_66736.jpg

Overview of levee crown at crossing looking downstream.

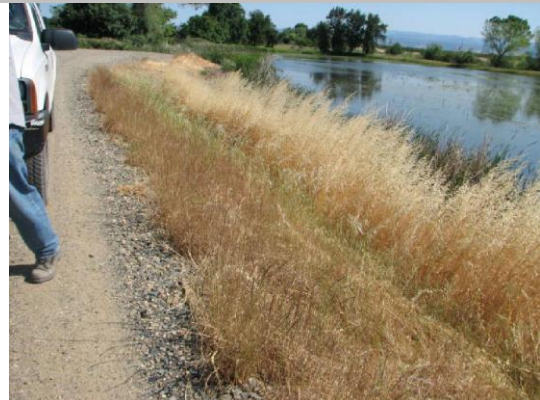
Photo 2 of 3 : UCIP_SP_2019_52190_66738.jpg

WS slope covered by dense vegetation.

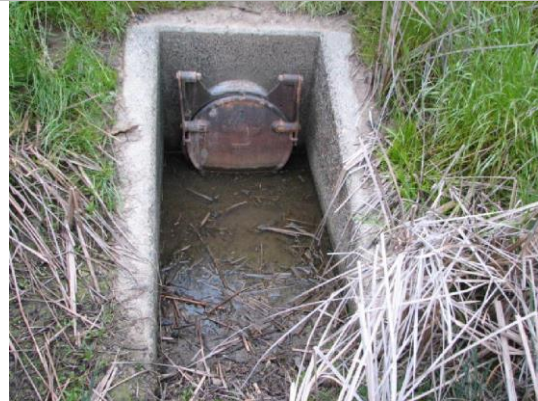
Photo 3 of 3 : UCIP_SP_2019_52190_66735.jpg

Comment Code					
Inspector Comment					
FS_ID:52190 DS_ID:16351 EP_NO: N/A Repair Type: No Action Needed Crossing Status: Found UCIP Comments: 6/14/2017 Both pipe ends were underwater during site visit. Pipe has been selected to be internally cleaned and inspected as part of the DMP project. (DWR Sutter Yard- AFreitag)11/16/2016 Crossing appears to be in good condition. (DWR Sutter Yard- AFreitag)4/28/2016 Both sides of the crossing were underwater during time of inspection.7/14/2015 Crossing appears in good condition. No noticeable issues to report.5/21/2014 Same as last inspection.12/2/2013 Same as last inspection.7/15/2013 Slopes have been cleared of vegetation and are in good condition.4/18/2012 Limited inspection on WS and LS slope due to dense vegetation. Need photos of cleared slopes. FIELD_STRUCT_DESC: 24-inch corrugate metal drainage pipe through the levee, 8.1 feet below the crown. Flap gate on the waterside (WS) end. Slide gate located on the landside (LS) end. Concrete "U" headwalls on both ends. [Additional Reference(s): DWR Levee Log, 1993. USACE Sacramento O&M Manual 519, June 1962 (HLM 3.80)] FS Date: 6/16/2017 12:33:16 PM

WS flap gate

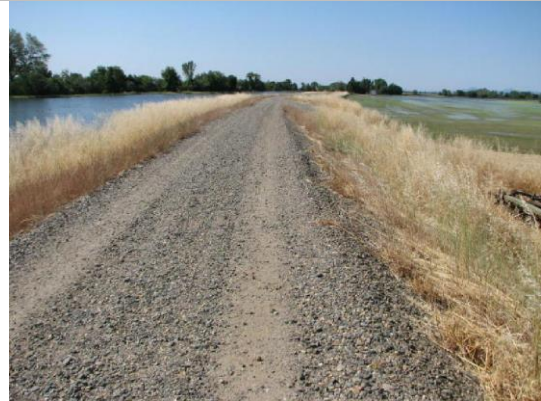
Photo 1 of 3 : UCIP_SP_2019_52191_66743.jpg

Overview of levee crown at crossing looking downstream.

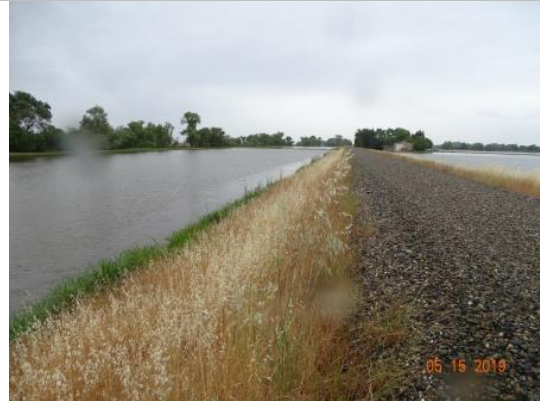
Photo 1 of 1 : SP_2019_MA0013_300_74_20190520_00144.jpg

LM Start	3.79	Rating **	U	Issue No.	74
LM End	18.50	Issue Type +	Ma	Location *	WS
Category	Earthen Levee			GPS Latitude/Longitude	
				Start	End
Item	Vegetation			39.545589 °	39.373436 °
				-121.707384 °	-121.850430 °
DWR ID	DWR_MA0013_01_s_2019_74				
Comment Code					
V1 : Control annual grass and weeds on the levee slopes and easements.					
Inspector Comment

View of the vegetation on the waterside slope. Spring 2019.

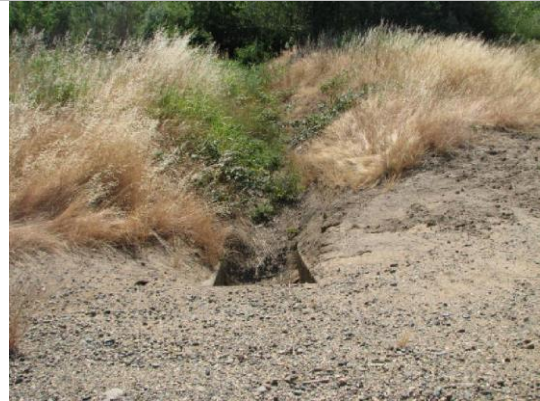
Photo 2 of 3 : UCIP_SP_2019_52193_66753.jpg

View of WS slope and toe.

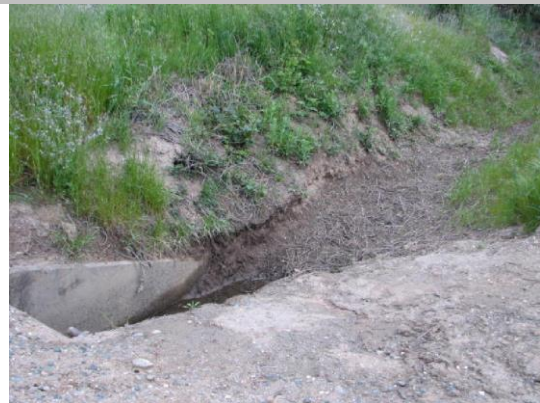
Photo 3 of 3 : UCIP_SP_2019_52193_66750.jpg

View of WS.

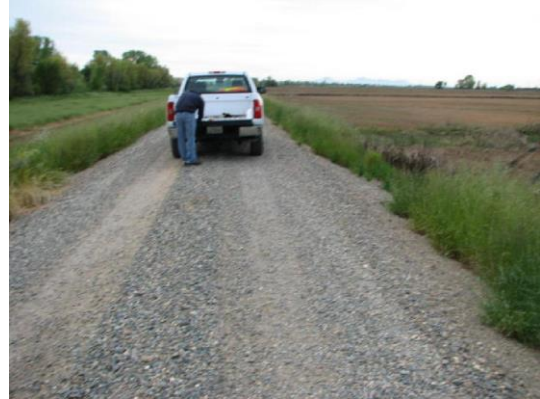
Photo 1 of 3 : UCIP_SP_2019_52194_66756.jpg

Overview of levee crown at crossing looking downstream at right bank of Cherokee Canal.

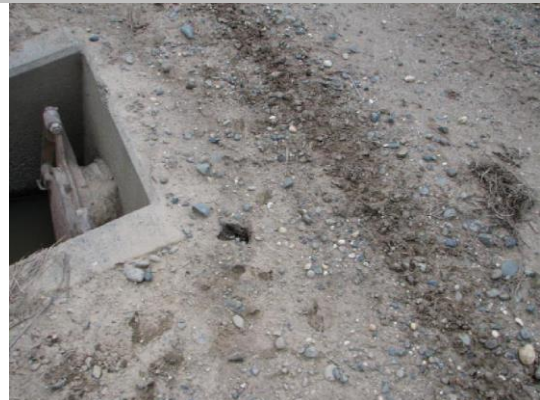
Photo 2 of 3 : UCIP_SP_2019_52194_66758.jpg

Burrow activity on WS slope.

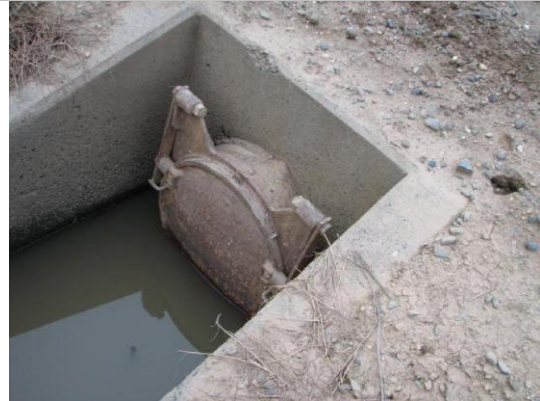
Photo 3 of 3 : UCIP_SP_2019_52194_66755.jpg

Item	DWR UCIP LMA Responsibility			39.530220 °	39.530220 °	
				-121.707940 °	-121.707940 °	
DWR ID	16355					
Comment Code						
Inspector Comment						
FS_ID:52194 DS_ID:16355 EP_NO: N/A Repair Type: No Action Needed Crossing Status: Found UCIP Comments: 6/14/2017 WS flapgate is submerged and appears to be half buried by sediment. LS slide gate is fully submerged on the edge of the rice field. Pipe has been selected to be internally cleaned and inspected as part of the DMP project. (DWR Sutter Yard- A/Freitag)11/16/2016 Crossing appears to be in good condition. (DWR Sutter Yard- A/Freitag)4/28/2016 Crossing appears to be in good condition.7/13/2015 LS screw gate was completely submerged but crossing appears to be in good condition.5/21/2014 Same as last inspection.12/2/2013 Same as last inspection.7/15/2013 No signs of burrowing activity on this inspection.4/18/2012 Burrow activity near crossing, burrow holes present on WS slope. FIELD_STRUCT_DESC: 24-inch corrugated metal drainage pipe through the levee 7.7 feet below the crown. Flap gate on the waterside (WS) end. Slide gate located on the landside (LS) end. Concrete "U" headwalls on both ends. [Additional Reference(s): DWR Levee Log, 1993. USACE Sacramento O&M Manual 519, June 1962 (HLM 4.94)] FS Date: 6/16/2017 12:55:37 PM

View of WS flap gate.

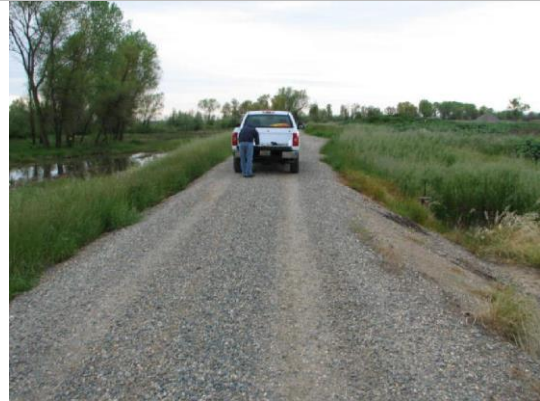
Photo 1 of 3 : UCIP_SP_2019_52195_66762.jpg

Overview of levee crown at crossing looking D/S on right bank of Cherokee Canal.

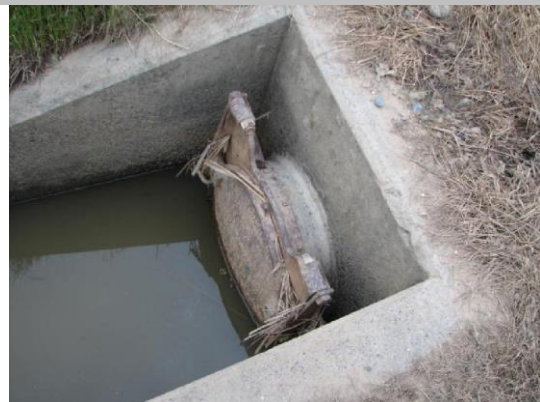
Photo 2 of 3 : UCIP_SP_2019_52195_66760.jpg

WS Flap Gate

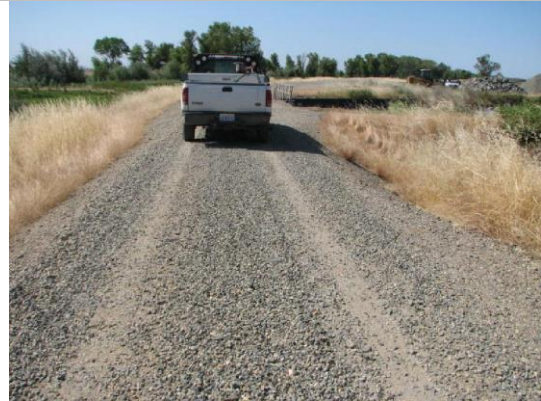
Photo 1 of 3 : UCIP_SP_2019_52196_66764.jpg

Overview of levee crown at crossing looking downstream.

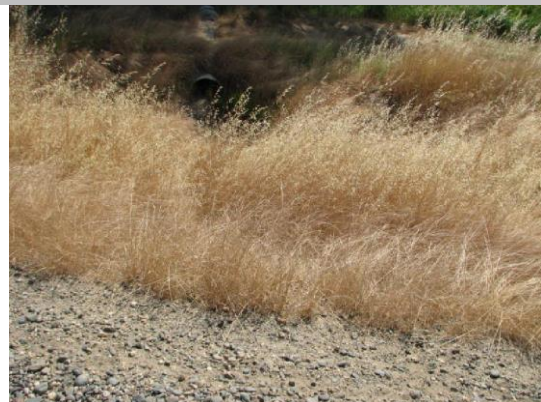
Photo 2 of 3 : UCIP_SP_2019_52196_66765.jpg

View of WS slope and channel.

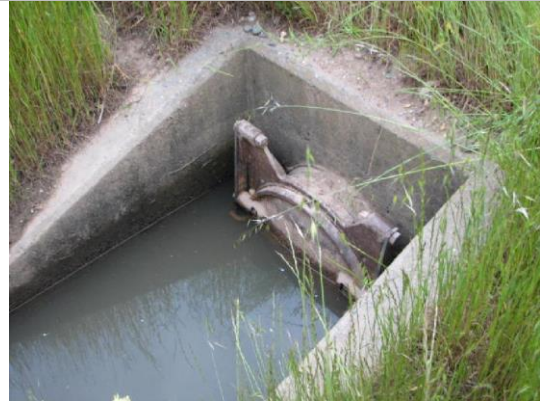
Photo 3 of 3 : UCIP_SP_2019_52196_66768.jpg

Comment Code						
Inspector Comment						
FS_ID:52196 DS_ID:16357 EP_NO: N/A Repair Type: Non-Urgent Crossing Status: Found UCIP Comments: 6/14/2017 WS flapgate is partially buried by sediment- needs to be dug out. LS appears to be in good condition. Pipe has been selected to be internally cleaned and inspected as part of the DMP project. (DWR Sutter Yard- AFreitag)11/16/2016 WS flap gate closed but blocked from opening by sediment. (DWR Sutter Yard- AFreitag)4/28/2016 WS flap gate blocked from opening by sediment.7/13/2015 WS flap gate is blocked from opening by sediment. Needs to be dug out.5/21/2014 Same as last inspection.12/2/2013 Same as last inspection.7/15/2013 Slopes have been cleared of vegetation and are in good condition.4/18/2012 Limited inspection on WS and LS slopes due to dense vegetation. Need photos of cleared slopes. FIELD_STRUCT_DESC: 24-inch corrugated metal drainage pipe through the levee, 8.6 feet below the crown. Flap gate on the waterside (WS) end. Concrete "U" headwalls an both ends. [Additional Reference(s): DWR Levee Log, 1993. USACE Sacramento O&M Manual 519, June 1962 (HLM 5.48)] FS Date: 6/16/2017 1:05:09 PM

View of WS flap gate.

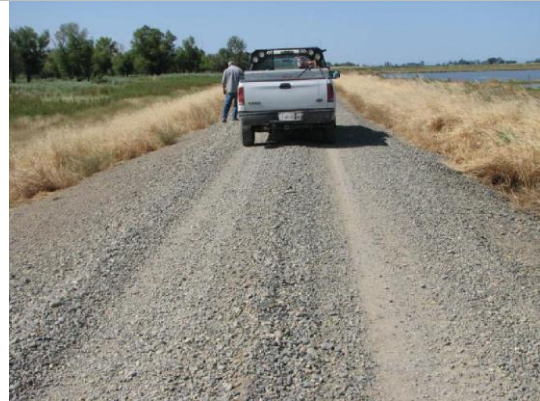
Photo 1 of 3 : UCIP_SP_2019_52202_66800.jpg

Overview of levee crown at crossing looking downstream.

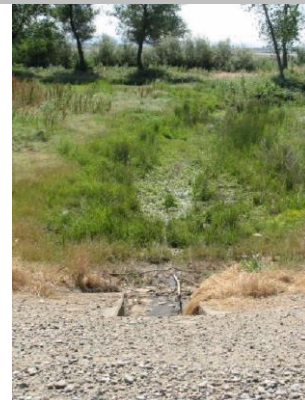
Photo 2 of 3 : UCIP_SP_2019_52202_66801.jpg

View of WS slope and toe.

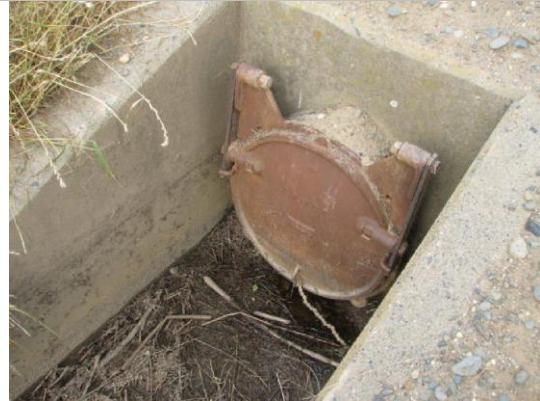
Photo 3 of 3 : UCIP_SP_2019_52202_66799.jpg

Flap gate WS

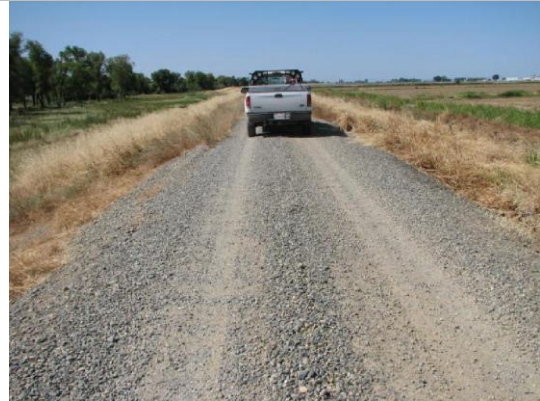
Photo 1 of 3 : UCIP_SP_2019_52203_66808.jpg

Overview of levee crown at crossing looking downstream.

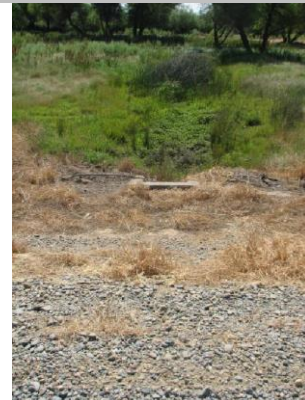
Photo 2 of 3 : UCIP_SP_2019_52203_66806.jpg

View of WS slope and toe.

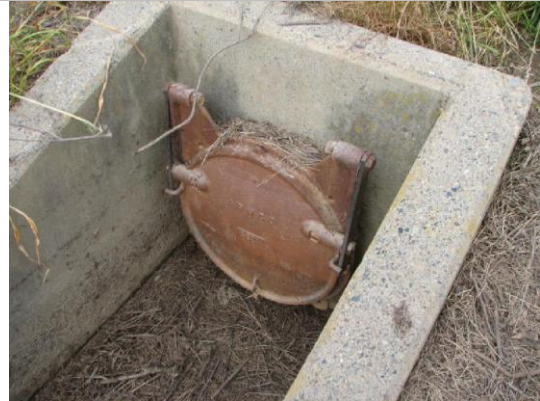
Photo 3 of 3 : UCIP_SP_2019_52203_66804.jpg

Comment Code						
Inspector Comment						
FS_ID:52203 DS_ID:16361 EP_NO: N/A Repair Type: Non-Urgent Crossing Status: Found UCIP Comments: 6/14/2017 WS appears to be in good condition. LS slide gate is buried and submerged. Pipe has been selected to be internally cleaned and inspected as part of the DMP project. (DWR Sutter Yard- AFreitag)11/16/2016 LS screwgate is buried and non-operational. (DWR Sutter Yard- AFreitag)4/28/2016 LS screwgate is still completely buried. 7/13/2015 LS screw gate is completely buried.5/21/2014 Same as last inspection.7/15/2013 WS slope has been cleared of vegetation and is in good condition. LS screw gate is still buried.12/2/2013 Same as last inspection.4/18/2012 LS slide gate is buried. Pipe is not visible on LS toe. Limited inspection on WS slope due to dense vegetation. FIELD_STRUCT_DESC: 24-inch corrugated metal drainage pipe through the levee, 7.4 feet below the crown. Flap gate on the waterside (WS) end. Slide gate on the landside (LS) end. Concrete "U" headwalls on both ends. [Additional Reference(s): DWR Levee Log, 1993. USACE Sacramento O&M Manual 519, June 1962 (HLM 6.34)] FS Date: 6/16/2017 1:51:41 PM

View of WS flap gate.

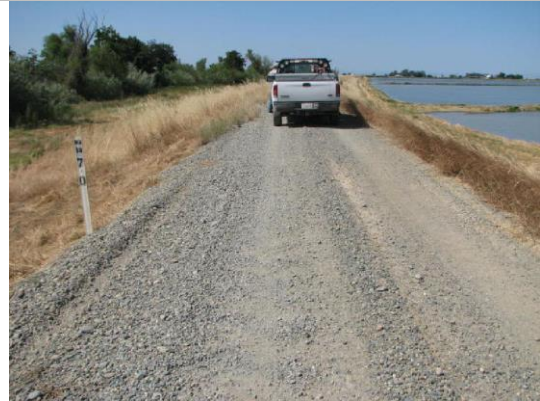
Photo 1 of 3 : UCIP_SP_2019_52211_66833.jpg

Comment Code						
Inspector Comment						
FS_ID:52211 DS_ID:16329 EP_NO: N/A Repair Type: Non-Urgent Crossing Status: Found UCIP Comments: 6/14/2017 LS slide gate is still damaged and needing to be replaced. WS appeared to be in good condition. Pipe has been selected to be internally cleaned and inspected as part of the DMP project. (DWR Sutter Yard- AFreitag)11/16/2016 Needs a new screw gate installed on the LS. (DWR Sutter Yard- AFreitag)4/28/2016 LS slide gate is still bent. Everyhting else with the crossing appeared ok.7/13/2015 LS screw gate needs to be replaced. Everything else with crossing seems to be in good condition.5/21/2014 Same as last inspection.12/2/2013 Same as last inspection.7/15/2013 Slopes have been cleared of vegetation and are in good condition. There were no apparent signs of settling. LS screw gate is still damaged.4/18/2012 LMA's inspection sheet of 2011 indicates settlement and visible corrosion. Damage/severe corrosion on screw gate where it bolts to headwall. No visible signs of settlement due to high vegetation cover. Limited inspection on WS and LS slopes due to dense vegetation. Need photos of cleared slopes for this crossing. FIELD_STRUCT_DESC: 24-inch corrugated metal drainage pipe through the levee, 9.8 feet below the crown. Flap gate on the waterside (WS) end. Slide gate on the landside (LS) end. Concrete headwall on both ends. [Additional Reference(s): DWR Levee Log, 1993. USACE Sacramento O&M Manual 519, June 1962 (HLM 7.10)] FS Date: 6/19/2017 10:17:38 AM

Overview of levee crown at crossing looking D/S.

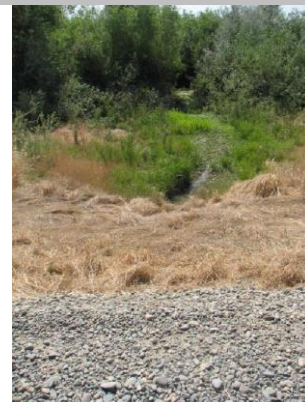
Photo 2 of 3 : UCIP_SP_2019_52211_66832.jpg

View of WS slope and toe.

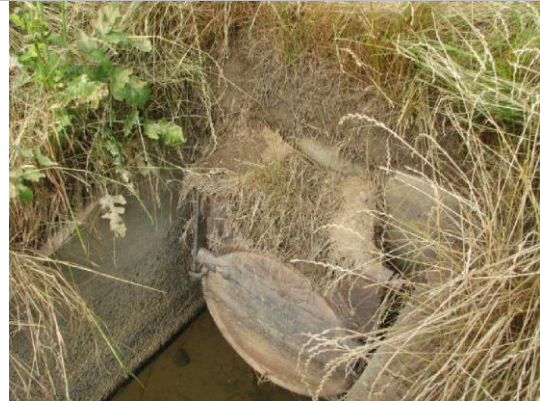
Photo 3 of 3 : UCIP_SP_2019_52211_66837.jpg

Comment Code						
Inspector Comment						
FS_ID:52211 DS_ID:16329 EP_NO: N/A Repair Type: Non-Urgent Crossing Status: Found UCIP Comments: 6/14/2017 LS slide gate is still damaged and needing to be replaced. WS appeared to be in good condition. Pipe has been selected to be internally cleaned and inspected as part of the DMP project. (DWR Sutter Yard- AFreitag)11/16/2016 Needs a new screw gate installed on the LS. (DWR Sutter Yard- AFreitag)4/28/2016 LS slide gate is still bent. Everyhting else with the crossing appeared ok.7/13/2015 LS screw gate needs to be replaced. Everything else with crossing seems to be in good condition.5/21/2014 Same as last inspection.12/2/2013 Same as last inspection.7/15/2013 Slopes have been cleared of vegetation and are in good condition. There were no apparent signs of settling. LS screw gate is still damaged.4/18/2012 LMA's inspection sheet of 2011 indicates settlement and visible corrosion. Damage/severe corrosion on screw gate where it bolts to headwall. No visible signs of settlement due to high vegetation cover. Limited inspection on WS and LS slopes due to dense vegetation. Need photos of cleared slopes for this crossing. FIELD_STRUCT_DESC: 24-inch corrugated metal drainage pipe through the levee, 9.8 feet below the crown. Flap gate on the waterside (WS) end. Slide gate on the landside (LS) end. Concrete headwall on both ends. [Additional Reference(s): DWR Levee Log, 1993. USACE Sacramento O&M Manual 519, June 1962 (HLM 7.10)] FS Date: 6/19/2017 10:17:38 AM

WS Flap Gate

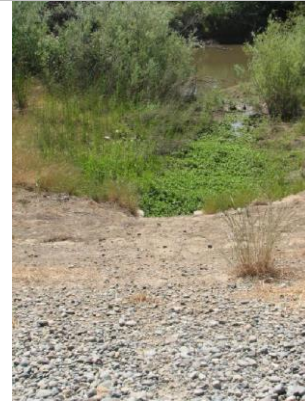
Photo 2 of 3 : UCIP_SP_2019_52212_66845.jpg

Comment Code						
Inspector Comment						
FS_ID:52212 DS_ID:16354 EP_NO: N/A Repair Type: Non-Urgent Crossing Status: Found UCIP Comments: 6/14/2017 LS slide gate stem still bent. WS appeared to be in good condition. Pipe has been selected to be internally cleaned and inspected as part of the DMP project. (DWR Sutter Yard- AFreitag)11/16/2016 Screw gate stem bent but gate is still operational. (DWR Sutter Yard- AFreitag)4/28/2106 Tested positive closure device the bent stem on the slide gate did not seem to affect its functions. Gate operable.7/13/2015 LS screw gate stem is still bent. Gate should still be able to close fully. The rest of the crossing seems to be in good condition.5/21/2014 Same as last inspection.12/2/2013 Same as last inspection.7/15/2013 Slopes have been cleared of vegetation and are in good condition. LS screw gate stem is still bent.4/18/2012 LS slide gate stem is bent and needs to be replaced. Limited inspection on WS and LS slope due to dense vegetation. Need photos of cleared slopes during next inspection. Confirmed flap gate on WS. This crossing was listed in the USACE Periodic Inspection report as Corp's inspect ID#USACE_CESPK_M13D_2011_p_0244 for submerged WS gate. FIELD_STRUCT_DESC: 24-inch corrugated metal drainage pipe through the levee, 11.2 feet below the crown. Flap gate on the waterside (WS) end. Slide gate on the landside (LS) end. Concrete "U" headwall on both ends. [Additional Reference(s): DWR Levee Log, 1993. USACE Sacramento O&M Manual 519, June 1962 (HLM 7.34)] FS Date: 6/19/2017 10:19:12 AM

View of WS slope and toe.

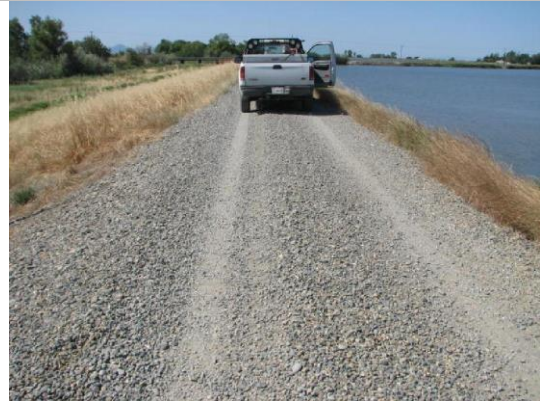
Photo 1 of 3 : UCIP_SP_2019_52213_66853.jpg

Comment Code						
Inspector Comment						
FS_ID:52213 DS_ID:16352 EP_NO: N/A Repair Type: No Action Needed Crossing Status: Found UCIP Comments: 6/14/2017 Crossing appears to be in good condition. Pipe has been selected to be internally cleaned and inspected as part of the DMP project. (DWR Sutter Yard- A Freitag)11/16/2016 Crossing appears to be in good condition. (DWR Sutter Yard- A Freitag)4/28/2016 Crossing appears to be in good condition.7/13/2015 WS ditch is getting to be heavily vegetated but it is not yet affecting flap gate operation. Vegetation needs to be cleared back some.5/21/2014 Same as last inspection.12/2/2013 Same as last inspection.7/15/2013 Slopes have been cleared of vegetation and are in good condition.4/18/2012 Limited inspection on WS and LS slopes due to dense vegetation. Need photos of cleared WS and LS slopes during next inspection. FIELD_STRUCT_DESC: 24-inch corrugated metal drainage pipe through the levee, 10.2 feet below the crown. Flap gate on the waterside (WS) end. Screw gate on the landside (LS) end. Concrete headwall on both ends. [Additional Reference(s): DWR Levee Log, 1993. USACE Sacramento O&M Manual 519, June 1962 (HLM 7.58)] FS Date: 6/19/2017 10:29:30 AM

View of levee crown at crossing looking D/S.

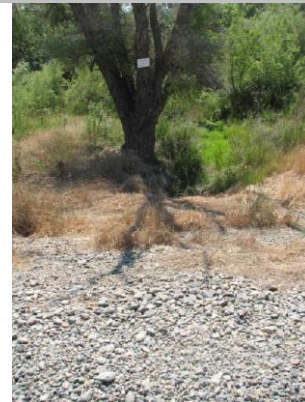
Photo 2 of 3 : UCIP_SP_2019_52213_66851.jpg

WS view of slope and channel.

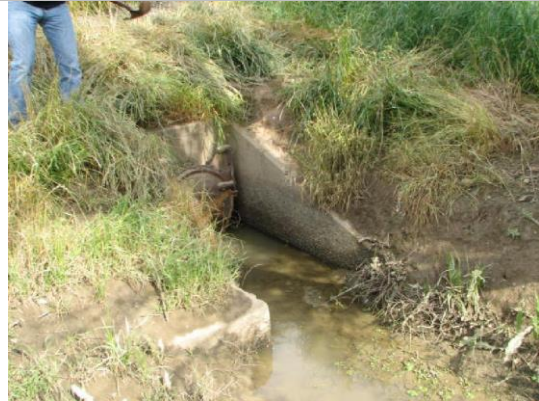
Photo 3 of 3 : UCIP_SP_2019_52213_66849.jpg

Item	DWR UCIP LMA Responsibility			39.496146 °	39.496146 °	
				-121.725160 °	-121.725160 °	
DWR ID	16352					
Comment Code						
Inspector Comment						
FS_ID:52213 DS_ID:16352 EP_NO: N/A Repair Type: No Action Needed Crossing Status: Found UCIP Comments: 6/14/2017 Crossing appears to be in good condition. Pipe has been selected to be internally cleaned and inspected as part of the DMP project. (DWR Sutter Yard- A Freitag)11/16/2016 Crossing appears to be in good condition. (DWR Sutter Yard- A Freitag)4/28/2016 Crossing appears to be in good condition.7/13/2015 WS ditch is getting to be heavily vegetated but it is not yet affecting flap gate operation. Vegetation needs to be cleared back some.5/21/2014 Same as last inspection.12/2/2013 Same as last inspection.7/15/2013 Slopes have been cleared of vegetation and are in good condition.4/18/2012 Limited inspection on WS and LS slopes due to dense vegetation. Need photos of cleared WS and LS slopes during next inspection. FIELD_STRUCT_DESC: 24-inch corrugated metal drainage pipe through the levee, 10.2 feet below the crown. Flap gate on the waterside (WS) end. Screw gate on the landside (LS) end. Concrete headwall on both ends. [Additional Reference(s): DWR Levee Log, 1993. USACE Sacramento O&M Manual 519, June 1962 (HLM 7.58)] FS Date: 6/19/2017 10:29:30 AM

View of WS flap gate. Dense vegetation on WS slope.

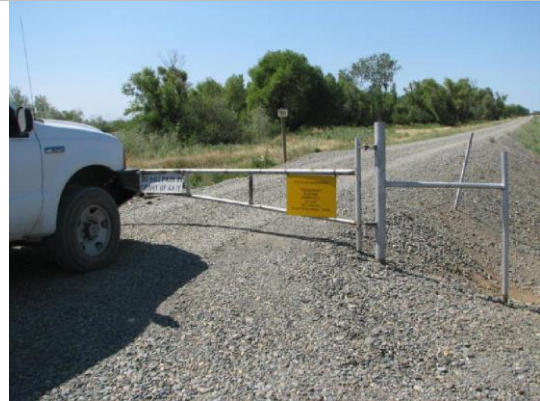
Photo 1 of 3 : UCIP_SP_2019_52217_66867.jpg

Comment Code					
Inspector Comment					
FS_ID:52217 DS_ID:16320 EP_NO: N/A Repair Type: No Action Needed Crossing Status: Found UCIP Comments: 6/14/2017 Debris down inside of WS riser. The rest of the crossing appears to be in good condition. Pipe has been selected to be internally cleaned and inspected as part of the DMP project. (DWR Sutter Yard- A/Freitag)11/16/2016 Crossing appears to be in good condition. (DWR Sutter Yard- A/Freitag)4/28/2016 Crossing appears to be in good condition.7/13/2015 The bottom of the entire pipe has about 8inch of sediment in it. Sediment is preventing the screw gate from fully closing. WS flap gate seems to be in good condition.5/21/2014 Same as last inspection.12/3/2013 Same as last inspection.7/15/2013 Same as last inspection. FIELD_STRUCT_DESC: 48-inch corrugated metal drainage pipe through the levee, 9.9 feet below the crown. Flap gate on the waterside (WS) end. Slide gate in corrugated metal pipe riser on the WS slope. Concrete "U" headwalls on both ends. Spillway grouted for 35 feet. [Additional Reference(s): DWR Levee Log, 1993. USACE Sacramento O&M Manual 519, June 1962 (HLM 7.76)] FS Date: 6/19/2017 12:43:02 PM

Overview of levee crown at crossing (past gate) looking D/S.

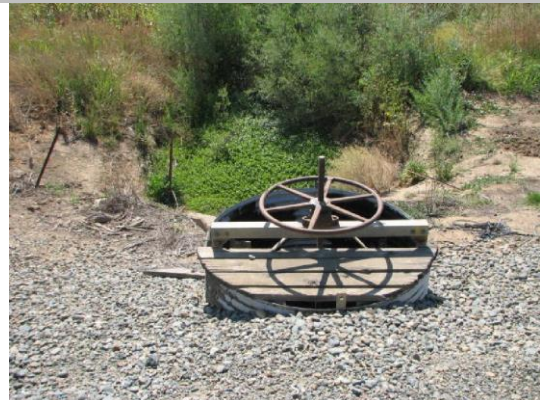
Photo 2 of 3 : UCIP_SP_2019_52217_66865.jpg

View of WS slope, corrugated metal riser with slide gate.

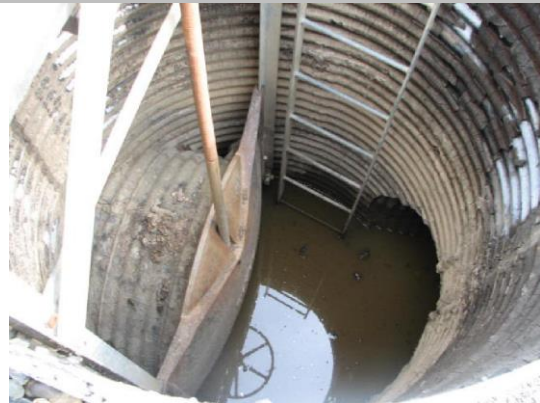
Photo 3 of 3 : UCIP_SP_2019_52217_66863.jpg

Item	DWR UCIP LMA Responsibility			39.493756 °	39.493756 °	
				-121.726570 °	-121.726570 °	
DWR ID	16320					
Comment Code						
Inspector Comment						
FS_ID:52217 DS_ID:16320 EP_NO: N/A Repair Type: No Action Needed Crossing Status: Found UCIP Comments: 6/14/2017 Debris down inside of WS riser. The rest of the crossing appears to be in good condition. Pipe has been selected to be internally cleaned and inspected as part of the DMP project. (DWR Sutter Yard- AFreitag)11/16/2016 Crossing appears to be in good condition. (DWR Sutter Yard- AFreitag)4/28/2016 Crossing appears to be in good condition.7/13/2015 The bottom of the entire pipe has about 8inch of sediment in it. Sediment is preventing the screw gate from fully closing. WS flap gate seems to be in good condition.5/21/2014 Same as last inspection.12/3/2013 Same as last inspection.7/15/2013 Same as last inspection. FIELD_STRUCT_DESC: 48-inch corrugated metal drainage pipe through the levee, 9.9 feet below the crown. Flap gate on the waterside (WS) end. Slide gate in corrugated metal pipe riser on the WS slope. Concrete "U" headwalls on both ends. Spillway grouted for 35 feet. [Additional Reference(s): DWR Levee Log, 1993. USACE Sacramento O&M Manual 519, June 1962 (HLM 7.76)] FS Date: 6/19/2017 12:43:02 PM

WS Slide gate

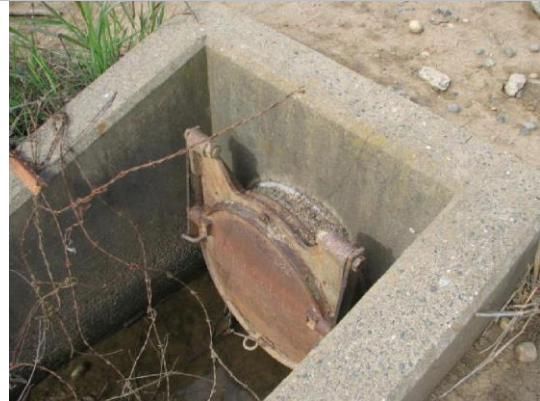
Photo 3 of 3 : UCIP_SP_2019_52218_66869.jpg

Item	DWR UCIP LMA Responsibility			39.489061 °	39.489061 °	
				-121.729430 °	-121.729430 °	
DWR ID	16321					
Comment Code						
Inspector Comment						
FS_ID:52218 DS_ID:16321 EP_NO: N/A Repair Type: No Action Needed Crossing Status: Found UCIP Comments: 6/14/2017 Crossing appears to be in good condition. Pipe has been selected to be internally cleaned and inspected as part of the DMP project. (DWR Sutter Yard- A Freitag)11/16/2016 Crossing appears to be in good condition. (DWR Sutter Yard- A Freitag)4/28/2016 Crossing appears to be in good condition.7/13/2015 Crossing appears to be in good condition. 5/21/2014 Same as last inspection.12/3/2013 Same as last inspection.7/15/2013 Same as last inspection.4/18/2012 Sediment build up against flashboards. Flashboards are in use on landside of levee. FIELD_STRUCT_DESC: 24-inch corrugated metal drainage pipe through the levee, 8.2 feet below the crown. Flap gate on the waterside (WS) end. Concrete "U" headwalls on both ends. Flashboards should be present on the landside (LS). [Additional Reference(s): DWR Levee Log, 1993. USACE Sacramento O&M Manual 519, June 1962 (HLM 8.12)] FS Date: 6/19/2017 12:45:23 PM

WS Flap gate

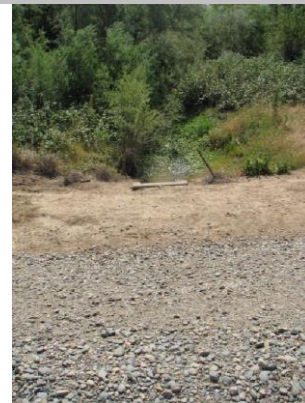
Photo 2 of 3 : UCIP_SP_2019_52219_66874.jpg

View of WS slope and toe.

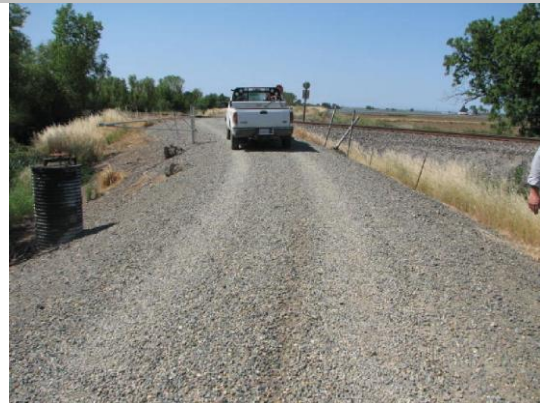
Photo 1 of 3 : UCIP_SP_2019_52223_66895.jpg

Comment Code					
Inspector Comment					
FS_ID:52223 DS_ID:16325 EP_NO: N/A Repair Type: Non-Urgent Crossing Status: Found UCIP Comments: 6/14/2017 Debris drifts built up around the WS slide gates- needs to be cleared away. LS appears to be n good condition. Pipe has been selected to be internally cleaned and inspected as part of the DMP project. (DWR Sutter Yard- AFreitag)11/16/2016 Crossing appears to be in good condition. (DWR Sutter Yard- AFreitag)4/28/2016 Crossing appears to be in good condition.7/13/2015 Crossing appears in good condition. No noticeable issues to report.5/21/2014 Same as last inspection.12/3/2013 Same as last inspection.7/15/2013 LS slope has been sprayed and cleared of vegetation and is in good condition.4/18/2012 Limited inspection on LS slope due to dense vegetation. Need photo of cleared vegetation from slopes and WS headwall. Minor debris scattered on WS slope. FIELD_STRUCT_DESC: 24-inch corrugated metal drainage pipe through the levee, 12.6 feet below the crown. Slide gate in corrugated metal pipe riser on the waterside (WS) slope. Slide gate on the WS end. Concrete "U" headwall on both ends. [Additional Reference(s): DWR Levee Log, 1993. USACE Sacramento O&M Manual 519, June 1962 (HLM 8.98)] FS Date: 6/19/2017 12:59:24 PM

Overview of levee crown at crossing looking D/S.

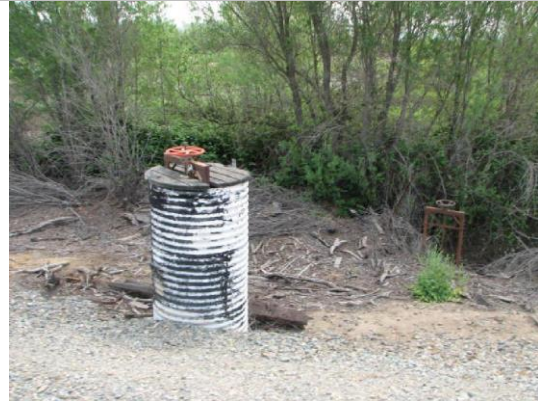
Photo 2 of 3 : UCIP_SP_2019_52223_66897.jpg

Comment Code						
Inspector Comment						
FS_ID:52223 DS_ID:16325 EP_NO: N/A Repair Type: Non-Urgent Crossing Status: Found UCIP Comments: 6/14/2017 Debris drifts built up around the WS slide gates- needs to be cleared away. LS appears to be n good condition. Pipe has been selected to be internally cleaned and inspected as part of the DMP project. (DWR Sutter Yard- AFreitag)11/16/2016 Crossing appears to be in good condition. (DWR Sutter Yard- AFreitag)4/28/2016 Crossing appears to be in good condition.7/13/2015 Crossing appears in good condition. No noticeable issues to report.5/21/2014 Same as last inspection.12/3/2013 Same as last inspection.7/15/2013 LS slope has been sprayed and cleared of vegetation and is in good condition.4/18/2012 Limited inspection on LS slope due to dense vegetation. Need photo of cleared vegetation from slopes and WS headwall. Minor debris scattered on WS slope. FIELD_STRUCT_DESC: 24-inch corrugated metal drainage pipe through the levee, 12.6 feet below the crown. Slide gate in corrugated metal pipe riser on the waterside (WS) slope. Slide gate on the WS end. Concrete "U" headwall on both ends. [Additional Reference(s): DWR Levee Log, 1993. USACE Sacramento O&M Manual 519, June 1962 (HLM 8.98)] FS Date: 6/19/2017 12:59:24 PM

View of WS slope with 2 slide gates.

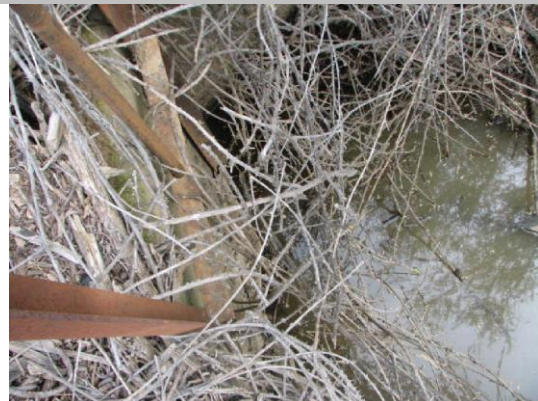
Photo 3 of 3 : UCIP_SP_2019_52223_66900.jpg

View of slide gate on WS. Debris blocking gate.

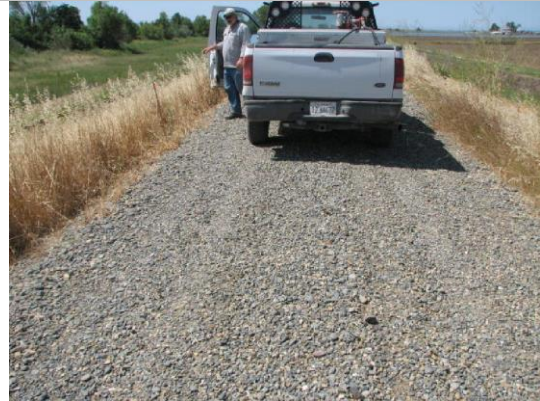
Photo 1 of 3 : UCIP_SP_2019_52227_66910.jpg

Comment Code					
Inspector Comment					
FS_ID:52227 DS_ID:16317 EP_NO: N/A Repair Type: No Action Needed Crossing Status: Found UCIP Comments: 6/14/2017 Crossing appears to be in good condition. Pipe has been selected to be internally cleaned and inspected as part of the DMP project. (DWR Sutter Yard- AFreitag)11/16/2016 Crossing appears to be in good condition. (DWR Sutter Yard- AFreitag)4/28/2016 Crossing appears to be in good condition. 7/13/2015 LS inlet has minor vegetation still. WS appears in good condition.5/21/2014 Same as last inspection.12/3/2013 Same as last inspection.7/15/2013 Slopes have been cleared of vegetation and are in good condition.4/18/2012 Limited inspection on WS and LS slopes due to dense vegetation. Need photos of cleared WS and LS slopes. This crossing was listed in the USACE Periodic Inspections as Corp's Insect ID# USACE_CESPK_M13D_2011_p_0278 for WS outlet sedimentation and sediment/grass at LS inlet. FIELD_STRUCT_DESC: 36-inch corrugated metal drainage pipe through the levee, 10.2 feet below the crown. Flap gate on the waterside (WS) end. Concrete "U" headwalls on both ends. Flashboards should be present on the landside (LS). [Additional Reference(s): DWR Levee Log, 1993. USACE Sacramento O&M Manual 519, June 1962 (HLM 9.09)] FS Date: 6/19/2017 1:09:21 PM

Overview of levee crown at crossing looking downstream.

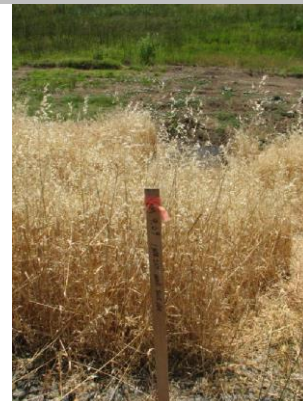
Photo 2 of 3 : UCIP_SP_2019_52227_66911.jpg

View of WS slope and toe.

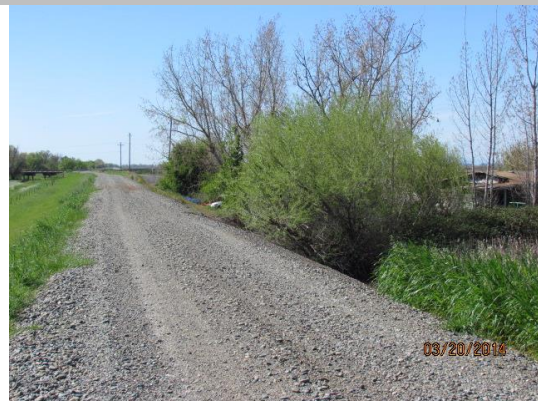
Photo 1 of 1 : SP_2019_MA0013_300_5_20190327_00002.jpg

View of the overgrown trees along the landside slope and toe.

LM Start	9.70	Rating **	M	Issue No.	5
LM End	9.72	Issue Type +	Ma	Location *	LS
Category	Earthen Levee			GPS Latitude/Longitude	
				Start	End
Item	Trim / Thin Trees			39.467170 °	39.466860 °
				-121.743887 °	-121.744108 °
DWR ID	DWR_MA0013_01_s_2012_5				
Comment Code					
T1 : Trim trees to at least five feet above ground level.					
Inspector Comment

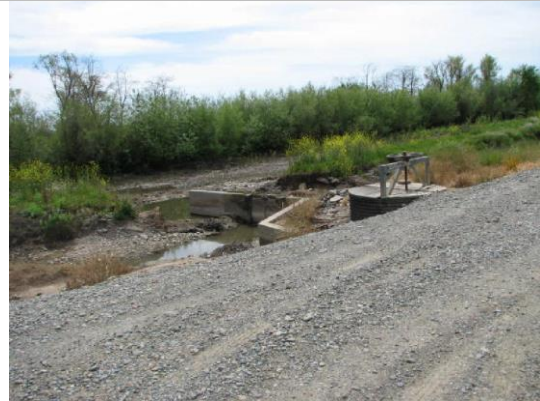
Photo 1 of 3 : UCIP_SP_2019_52232_66926.jpg

Comment Code					
Inspector Comment					
FS_ID:52232					
DS_ID:16332					
EP_NO: N/A					
Repair Type: No Action Needed					
Crossing Status: Found					
UCIP Comments: 6/15/2017 Crossing appears to be in good condition.					
Pipe has been selected to be internally cleaned and inspected as part					
of the DMP project. (DWR Sutter Yard- AFreitag)11/16/2016 Crossing					
appears to be in good condition. (DWR Sutter Yard-					
AFreitag)4/28/2016 Crossing appears to be in good					
condition.7/13/2015 Crossing appears in good condition. No					
noticeable issues to report.5/21/2014 Same as last					
inspection.12/3/2013 Same as last inspection.7/15/2013 Same as					
last inspection.					
FIELD_STRUCT_DESC: 60-inch corrugated metal drainage pipe					
through the levee, 11.5 feet below the crown. Slide gate in corrugated					
metal pipe riser on the waterside (WS) slope. Concrete "U" headwall on					
both ends and weir in channel. Crossing is used as an irrigation turnout.

View of WS corrugated metal riser and concrete wall.

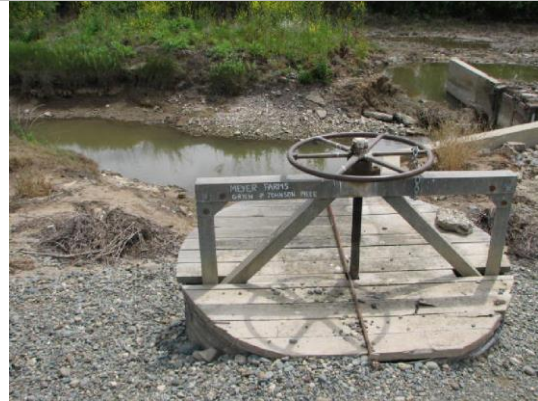
Photo 2 of 3 : UCIP_SP_2019_52232_66925.jpg

Item	DWR UCIP LMA Responsibility			39.449886 °	39.449886 °	
				-121.755050 °	-121.755050 °	
DWR ID	16332					
Comment Code						
Inspector Comment						
FS_ID:52232 DS_ID:16332 EP_NO: N/A Repair Type: No Action Needed Crossing Status: Found UCIP Comments: 6/15/2017 Crossing appears to be in good condition. Pipe has been selected to be internally cleaned and inspected as part of the DMP project. (DWR Sutter Yard- AFreitag)11/16/2016 Crossing appears to be in good condition. (DWR Sutter Yard- AFreitag)4/28/2016 Crossing appears to be in good condition. 7/13/2015 Crossing appears in good condition. No noticeable issues to report.5/21/2014 Same as last inspection.12/3/2013 Same as last inspection.7/15/2013 Same as last inspection. FIELD_STRUCT_DESC: 60-inch corrugated metal drainage pipe through the levee, 11.5 feet below the crown. Slide gate in corrugated metal pipe riser on the waterside (WS) slope. Concrete "U" headwall on both ends and weir in channel. Crossing is used as an irrigation turnout. [Additional Reference(s): DWR Levee Log, 1993. USACE Sacramento O&M Manual 519, June 1962 (HLM 11.21)] FS Date: 6/19/2017 1:17:54 PM

Corrugated metal riser with owner information.

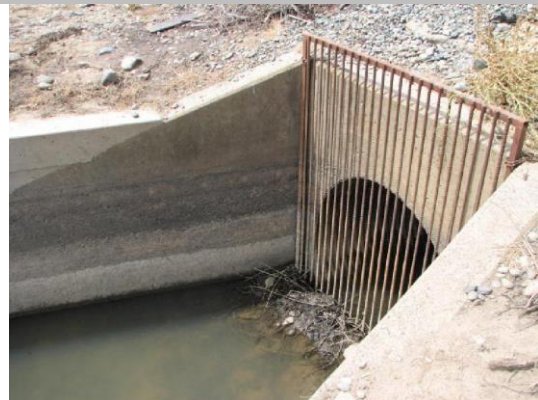
Photo 3 of 3 : UCIP_SP_2019_52232_66928.jpg

Trash rack on WS headwall.

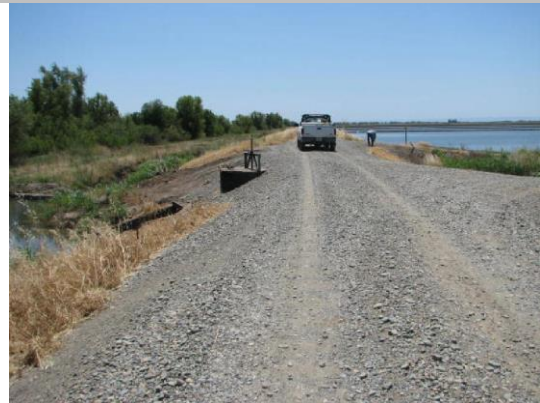
Photo 1 of 3 : UCIP_SP_2019_52233_66934.jpg

Comment Code					
Inspector Comment					
FS_ID:52233 DS_ID:16333 EP_NO: N/A Repair Type: No Action Needed Crossing Status: Found UCIP Comments: 6/15/2017 Crossing appears to be in good condition. Pipe has been selected to be internally cleaned and inspected as part of the DMP project. (DWR Sutter Yard- AFreitag)11/17/2016 Crossing appears to be in good condition. (DWR Sutter Yard- AFreitag)4/28/2016 Crossing appears to be in good condition.7/13/2015 Crossing appears in good condition. No noticeable issues to report.5/21/2014 Same as last inspection.12/3/2013 Same as last inspection.7/15/2013 Same as last inspection. FIELD_STRUCT_DESC: 60-inch corrugated metal drainage pipe through the levee, 11.3 feet below the crown. Slide gate in corrugated metal pipe riser on the waterside (WS) slope. Concrete "U" headwall on both ends. Crossing is used as an irrigation turnout bar code plate located on the WS slide gate (identified as 145). [Additional Reference(s): DWR Levee Log, 1993. USACE Sacramento O&M Manual 519, June 1962 (HLM 11.78)] FS Date: 6/19/2017 1:20:52 PM

Overview of levee crown at crossing looking downstream.

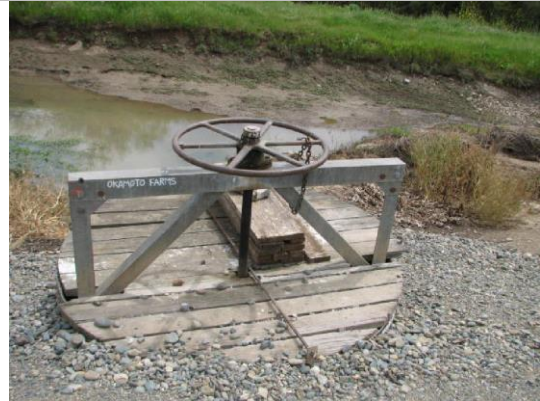
Photo 2 of 3 : UCIP_SP_2019_52233_66932.jpg

WS slide gate with owner information.

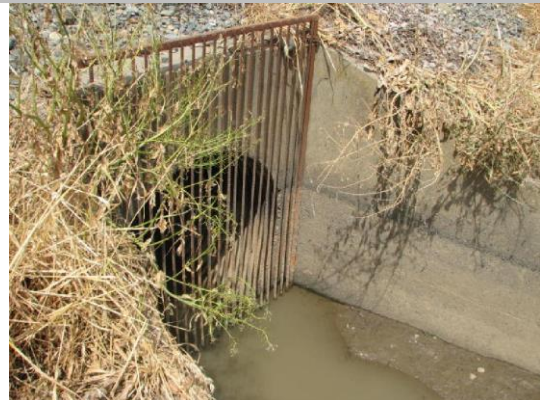
Photo 3 of 3 : UCIP_SP_2019_52233_66930.jpg

Trash rack on WS headwall.

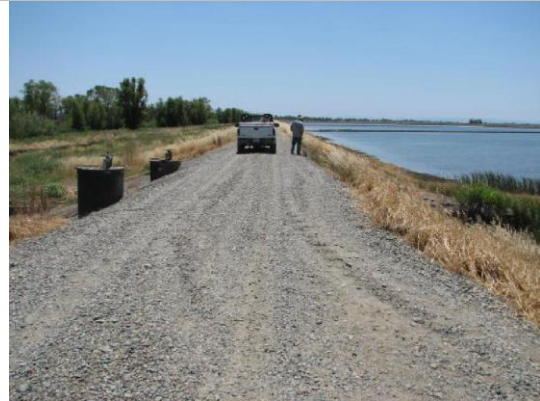
Photo 1 of 3 : UCIP_SP_2019_52234_66940.jpg

Comment Code						
Inspector Comment						
FS_ID:52234 DS_ID:16334 EP_NO: N/A Repair Type: Non-Urgent Crossing Status: Found UCIP Comments: 6/15/2017 WS pipe end still unknown- try to locate using GPR/ utility locator. Pipe has been selected to be internally cleaned and inspected as part of the DMP project. (DWR Sutter Yard- A/Freitag)11/17/2016 Cannot locate the WS pipe end. (DWR Sutter Yard- A/Freitag)4/28/2016 Crossing appears to be in good condition but could not locate the WS pipe end.7/13/2015 New screw gate installed inside the WS standpipe. 5/21/2014 Same as last inspection.12/3/2013 Same as last inspection.7/15/2013 Slopes have been cleared of vegetation and are in good condition. Still no sign of WS end of pipe.4/18/2012 Limited inspection on WS and LS slope due to dense vegetation. WS outlet of pipe not found. Need photos of cleared WS and LS slopes. Determine if WS outlet daylights after WS slope is cleared. FIELD_STRUCT_DESC: 30-inch corrugated metal drainage pipe through the levee, 11 feet below the crown. Slide gate in corrugated metal pipe riser on the waterside (WS) slope. Concrete "U" headwall on the landside (LS). [Additional Reference(s): DWR Levee Log, 1993. USACE Sacramento O&M Manual 519, June 1962 (HLM 12.38)] FS Date: 6/19/2017 1:22:23 PM

Overview of levee crown at crossing looking downstream.

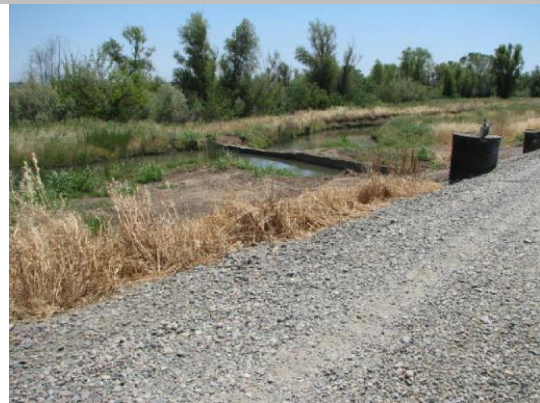
Photo 2 of 3 : UCIP_SP_2019_52234_66936.jpg

View of WS slope and channel.

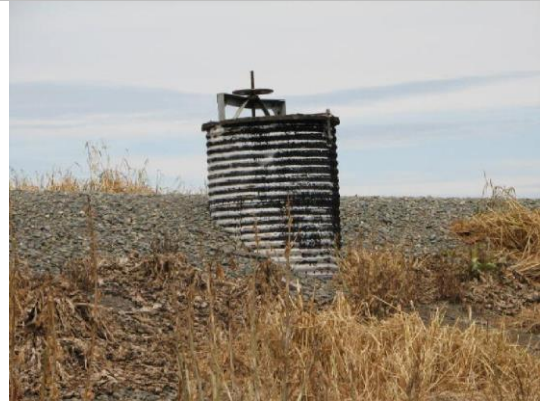
Photo 3 of 3 : UCIP_SP_2019_52234_66939.jpg

Slide gate located on WS slope.

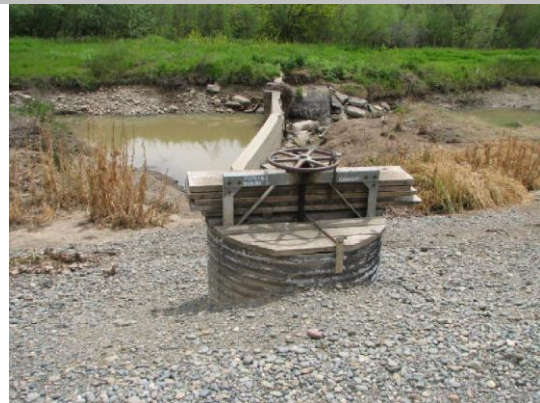
Photo 2 of 3 : UCIP_SP_2019_52235_66947.jpg

View from levee crown of WS slope and channel.

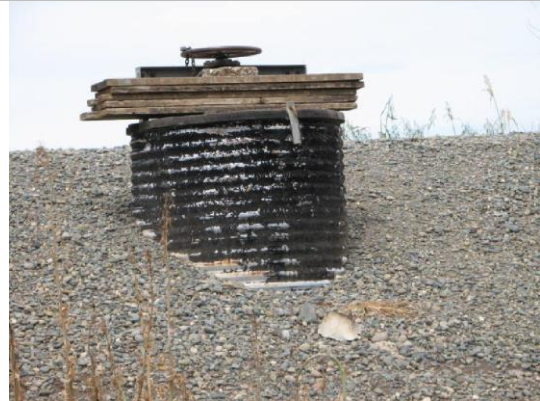
Photo 3 of 3 : UCIP_SP_2019_52235_66948.jpg

Water side screw gate located near crown hinge

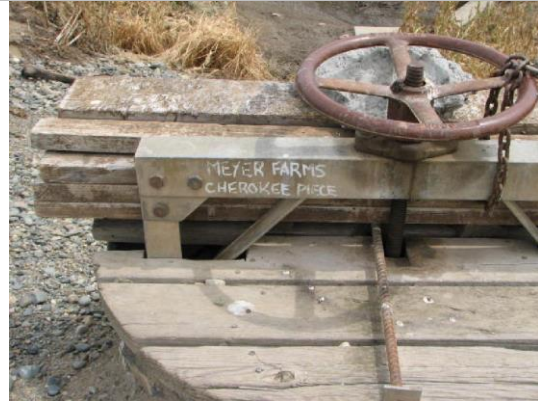
Photo 3 of 3 : UCIP_SP_2019_52236_66951.jpg

Item	DWR UCIP LMA Responsibility			39.428070 °		39.428070 °
				-121.770080 °		-121.770080 °
DWR ID	16336					
Comment Code						
Inspector Comment						
FS_ID:52236 DS_ID:16336 EP_NO: N/A Repair Type: Non-Urgent Crossing Status: Found UCIP Comments: 6/15/2017 Slide gate still missing from inside of WS standpipe. Pipe has been selected to be internally cleaned and inspected as part of the DMP project. (DWR Sutter Yard- A/Freitag)11/17/2016 Slide gate still missing from inside the WS standpipe. (DWR Sutter Yard- A/Freitag)4/28/2016 Slide gate was removed from inside the WS standpipe.7/13/2015 New screw gate installed on the WS pipe end in the irrigation ditch.5/21/2014 Same as last inspection.12/3/2013 Same as last inspection.7/15/2013 Same as last inspection.4/18/2012 Irrigation turnout. Not in use during April 2012 Inspection. During the follow up May 2012 Inspection structure was being used as irrigation turnout, reason for barcode tags. FIELD_STRUCT_DESC: 30-inch corrugated metal drainage pipe through the levee, 10.7 feet below the crown. Slide gate in corrugated metal pipe (CMP) riser on the waterside (WS) slope. Concrete "U" headwalls on both ends. This crossing is used as an irrigation turnout bar code plate located on the WS slide gate (identified as 141 and 142). [Additional Reference(s): DWR Levee Log, 1993. USACE Sacramento O&M Manual 519, June 1962 (HLM 12.94)] FS Date: 6/19/2017 1:28:43 PM

Slide gate located on WS slope. Owner information marked on gate.

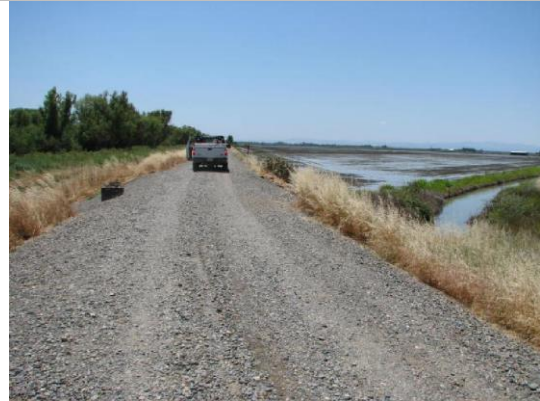
Photo 1 of 3 : UCIP_SP_2019_52238_66966.jpg

Overview of levee crown at crossing looking downstream.

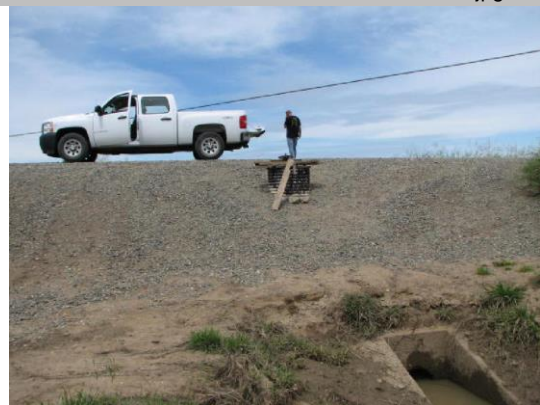
Photo 2 of 3 : UCIP_SP_2019_52238_66963.jpg

View of WS slope.

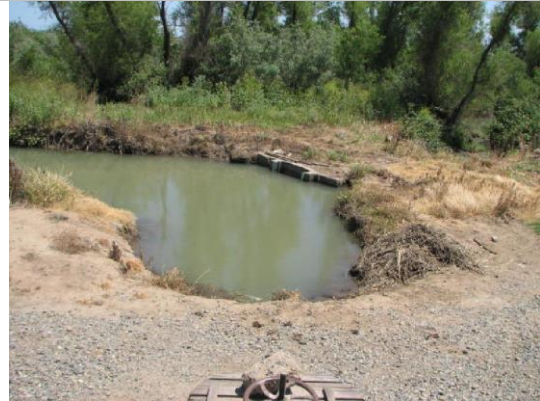
Photo 3 of 3 : UCIP_SP_2019_52238_66967.jpg

View of WS slope and channel.
